### Study on incidents of explosions on chemical and product tankers

#### Report of the activities of the Inter-Industry Working Group (IIWG)

#### Report of the activities of the Inter-Industry Working Group (IIWG): Incident Review Analysis

**INCIDENT REVIEW TASK GROUP FINAL REPORT**

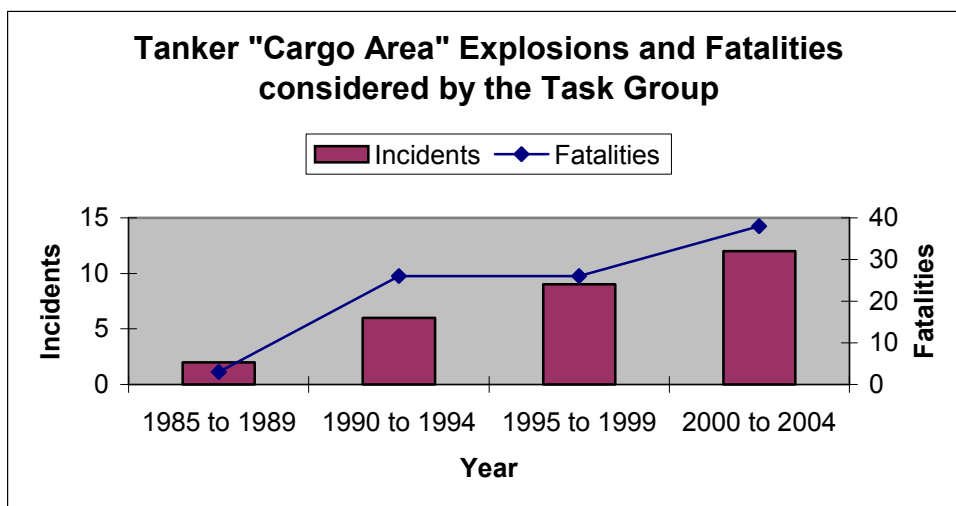
- 5.1 The most significant contributory factor to the incident causes was a failure to follow or understand cargo operation guidelines and procedures (at both shipboard and ship management level). *Had the above guidelines been followed, many incidents may have been avoided.*
- 5.2 The Incident investigation reports reviewed did not indicate any failures or discrepancies within the existing ISGOTT or the ICS Tanker Safety Guide (Chemicals) guidelines.
- 5.3 The 35 reviewed incident investigations show the following (unadjusted) trend since 1985.
